EcoSummary

Silver River Springs

4/9/02

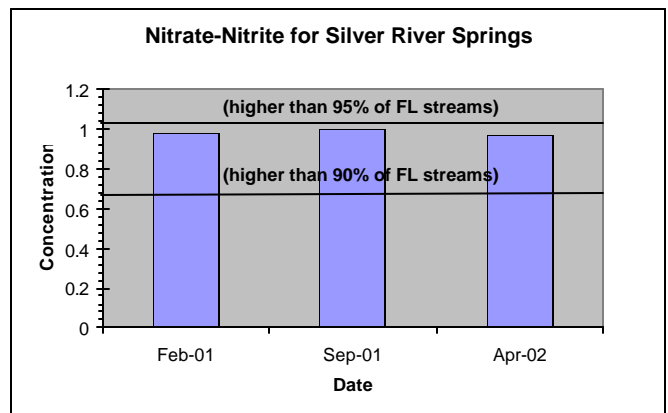
Figure 3. Nitrate-Nitrite Evaluation

The nitrate-nitrite concentrations (1.0 mg/L) at the sampling site were higher than those found in 90% of Florida streams (0.64 mg/L) (Figure 2). Elevated nitrite-nitrate levels in Silver River Springs are related to nitrogen loading in the recharge basin. The ammonia concentration (0.01 mg/L) was below the detection limit, while the total Kjeldahl nitrogen concentration (0.064 mg/L) was less than the minimum quantitation limit.

In conclusion, elevated nitrate-nitrate levels in Silver River Springs appeared to be the main stressor associated with a relatively low quality algal community.
